DATE: February 27, 2018

LOCATION: Lift Station #2 (LS2)

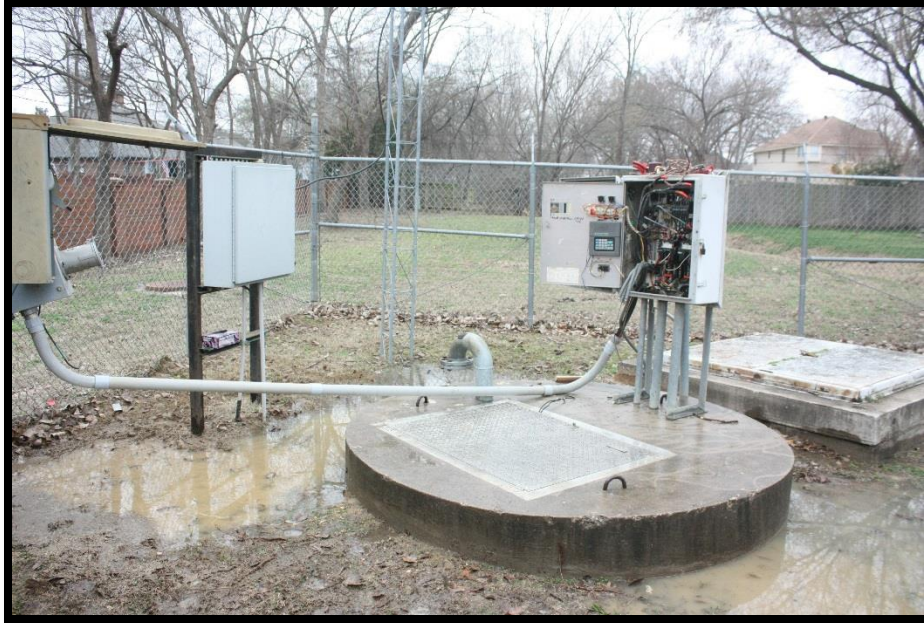
OCCURRENCE: A sewer overflow estimated at 600 gallons was observed from 8:10 a.m. until 10:40 a.m. on February 27, 2018.

CAUSE AND EFFECT: A short in the power feed from Oncor's transformer to the lift station pumps resulted in a loss of power to the lift station pumps. The power loss was first noted at 9:09 PM, February 26, 2018, after a high-level alarm was triggered by the system to the on-call operator.

CORRECTIVE ACTION(S): Oncor installed a new transformer and Walker Electric, our contractor, installed a new temporary feed, bypassing the damaged power feed, from the transformer. Power was restored to the lift station February 27, 2018 at approximately 2:00 p.m.
